# PRELIMINARY INVESTIGATION INTO THE DAMAGE OF THE HORIZONTAL STABILIZER OF MOTOR GLIDER DUE TO LOW ENERGY IMPACT

**Piotr Czarnocki**

Institute of Aeronautics and Applied Mechanics Warsaw University of Technology  
Nowowiejska 24, 00-665 Warsaw

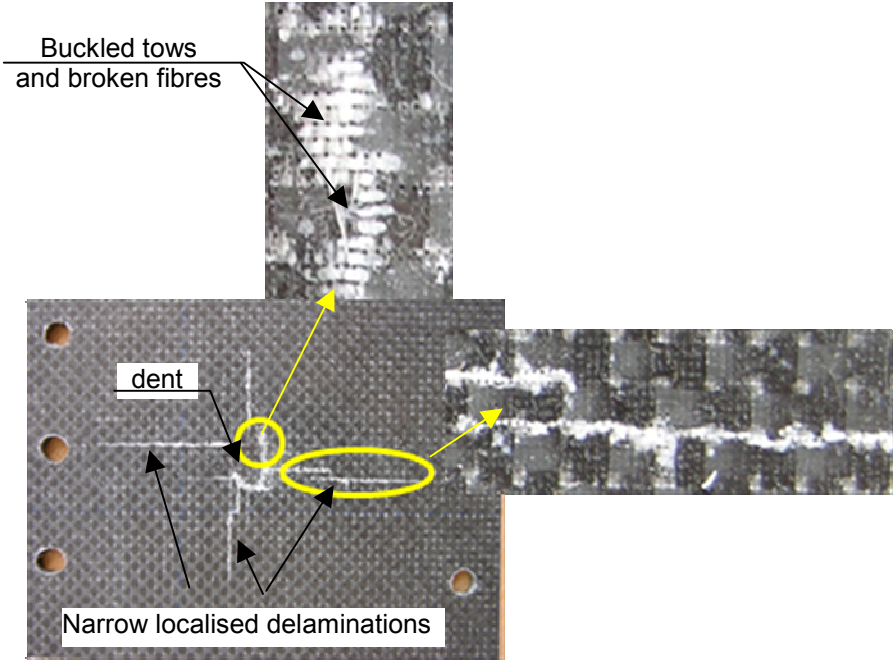
Figure 6: Damage pattern

There is pronounced difference between an impact damage of the sandwich structure under consideration, Fig.6, and that of solid laminate. Extensive description of the latter can be found in [1]. The damage produced included fracture of glass and carbon reinforcements of the outer facesheet, partially crushed core and a dent. No extensive delamination was found. The delaminations were very narrow and parallel to warp and perpendicular to weft tows. Some fibers of the tows perpendicular to the delamination paths were broken. Probably, the fibre brackage resulted from the localized bending of reinforcement which was possible due to its prior disbonding and buckling. The core did not fracture, however local dent of outer face was visible as well as small bump at the inner face surface, below the impact point.

- Impact damage of sandwich structure of extremely thin facesheets noticeably differs from that of solid laminate and is not well understood
- Mechanisms of such a damage formation must be investigated
- To estimate impact damage severity the fracture mechanics tools should be used

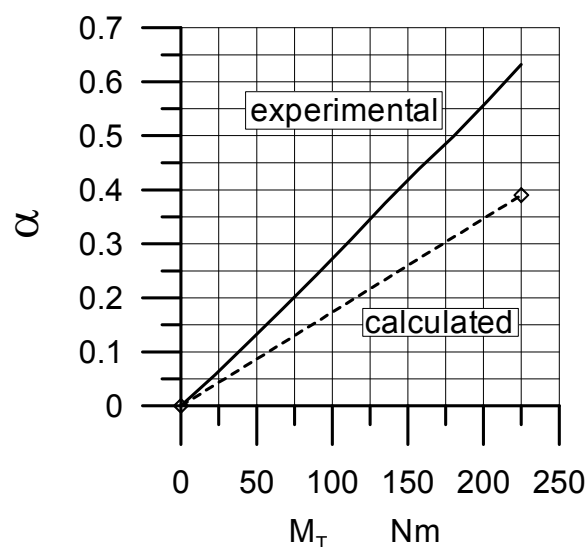
Figure 7: Stiffness of stabilizer section. Numerical and experimental estimation.

Results of the numerical analysis showed that the stiffness change due to crack formation is about 0.1% of the initial one and is meaningless. Comparison of the experimental and numerical results indicate that the FE model is too stiff and needs improvement.
